Recommendations for Injury Prevention in Transport Aviation Accidents

Anita E. Grierson Simula Technologies, Inc.

Lisa E. Jones
NASA Langley Research Center

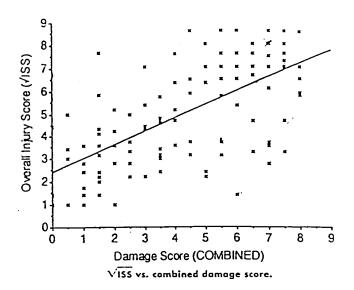
Figure 1.

In a detailed study of the 1989 Kegworth accident, White, et al., correlated the structural damage to the severity of injury (Reference 9). Structural damage to the aircraft fuselage, floor, and interior structure was greatest near the large breaks in aircraft structure. Their work showed a positive correlation between structural damage of the interior and the seating system and the severity of injury as measured through an Injury Severity Score (ISS) (Figure 1). The highest interior damage scores were in the areas of fuselage disruption. Fatalities predominantly occurred in the section of aircraft forward of the wingbox, and in the area between the wingbox and the tail section.

Positive correlation between aircraft and seat damage and Injury Severity Score in the 1989 Kegworth accident (Reference 9).

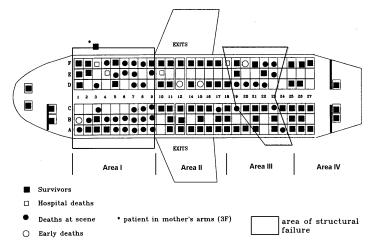
Figure 2.
Breakdown of injury severity (Reference 11)

Figure 2 shows the injury breakdown for the 1989 Kegworth accident. For analysis of structural damage, the Boeing 737 aircraft was divided into four areas based on the breaks in the aircraft's structure. Area I

represented the passenger compartment from Row 1 to Row 9. Structural damage was worst in Rows 6-9 as the aircraft broke apart in this area. Area II was over the wing box. The aircraft structure remained relatively intact in this area. Area III was from the rear of the wing box to a break in the aircraft forward of the tail section. The right side of the aircraft in this area suffered severe structural damage. The aircraft hit the embankment at a slight yaw angle, which led to excessive crushing of the right side of the aircraft in this area. Area IV was the tail area of the aircraft that remained intact. As mentioned previously, survivability in this accident could be directly correlated with the degree of structural damage.

Area I was crushed and floor integrity was lost. All of the floor beams failed in this area, causing all of the seats to become loose and literally pile up on top of each other. Recovered seat backs from this area showed damage. presumably from contact with the person in the row behind the seat. Some seat failures were in evidence, but investigators speculated that the seat failure was preceded by the floor failure. Seat damage indicated that loading in this area was likely greater than 16 G, and was probably closer to 20 G. The majority of occupants in this section, particularly those near the rear break in the section, were fatally injured, most suffering multiple extreme blunt trauma injuries. It is clear that an increase in the crashworthiness of the floor structure is a prerequisite for other increases in survivability in this section of the aircraft.

In Area II, over the aircraft wings, the floor was reinforced with intercostal members. The floor showed evidence of high decelerative loading, but did not experience the same massive failure as in Area I. The seats had varying levels of damage consistent with forward and downward loading; however, all but two of the seats remained attached to the seat track and floor. Based on seat deformation, it could be determined that loads transferred to the seats in this section were at least as high as the loads in Area I. However, since the floor

structure and the seats remained relatively intact, survivability was high. There were only four fatalities in this area, two of which were attributed to posterior head impact from an overhead luggage bin (Reference 9). Injuries in this area included a significant number of lower extremity and pelvic injuries. The type of lower extremity injury suffered likely depended upon the initial position of the lower extremity and upon the failure or deformation of the seat. Foot and ankle injuries were prevalent when the feet became entrapped in the deforming or failing seats. Knee and pelvic injuries likely resulted when passengers slid forward in their seats to contact the seat in front of them. Virtually all passengers had pelvic bruising from the lap belts, with five iliac fractures attributed to seat belt loading. Several comminuted tibia/fibula fractures were also present. The reinforcement in floor structure, as compared to Area I, clearly contributed to increased survivability in this section. However, that in itself was not sufficient to prevent serious injuries, but merely shifted injury to potentially less fatal mechanisms. Seat deformation and the lack of sufficient occupant restraint within the seat also contributed to serious injury.

In Area III, the aircraft floor was also disrupted, but to a lesser extent than in Area I. Damage came as a result of both aircraft break-up aft of the wingbox and the crushing of the right side of the aircraft. Seat attachment integrity and seat damage corresponded positively with floor and structural damage, as did the level of occupant survivability. Many of the occupants in this area of the aircraft required extrication, as they were trapped in their seats. Seat deformation indicated lower seat loading than in other sections. Of the seats that were severely damaged, all but one had detached seat backs, indicating that the seats suffered severe loading from behind as the occupants in those seats were thrown forward when their seats were released. The fatalities in this section were similar in nature to those in Area I. with crushing injuries predominating in the area of aircraft crush. Where there was less aircraft structural damage and subsequently less floor and seat damage, the injuries were similar to those in Area II.

Area IV, the tail section, broke loose, jack-knifed, and ended up partially inverted. The tail section experienced a less-severe scenario than did the more forward sections with less structural deformation. This is not surprising, since the aircraft impacted on an upward slope with the crushing of forward sections absorbing impact energy. Correspondingly, there were no fatalities in this section and the overall level of injury in this section was the least severe.

By comparing the areas of damage and injuries incurred throughout the aircraft, it can clearly be seen that the retention of floor integrity was a critical factor in increased occupant survivability. Where the floor remained intact, the 16-G seats appear to have been stressed to the limits of their capabilities, as evidenced by the failure and deformation of the seats. However, for the most part, the seats maintained their connection to

To increase survivability, the requirements for floor crashworthiness must be increased. Without an increase in the structural integrity of the floor, the improvements in occupant protection afforded by improved seating systems and other interior safety upgrades will not reach their potential. The Air Accidents Investigation Board recommended an increase in floor structural integrity following the 1989 Kegworth crash (Reference 12). Specifically, a dynamic design standard that relates to human tolerance levels, or at least the seat dynamic standard, should be required. Additionally, it is important to seek to improve tolerance to out-ofplane loading, and to provide for multiple load paths. It is conceivable that floor strength could also be increased non-uniformly to meet the needs of the different aircraft sections. Increasing the crashworthiness of the floor structure must be a long-term consideration for improved survivability in aircraft accidents.
